### Saskatchewan Salt Phytoremediation Project

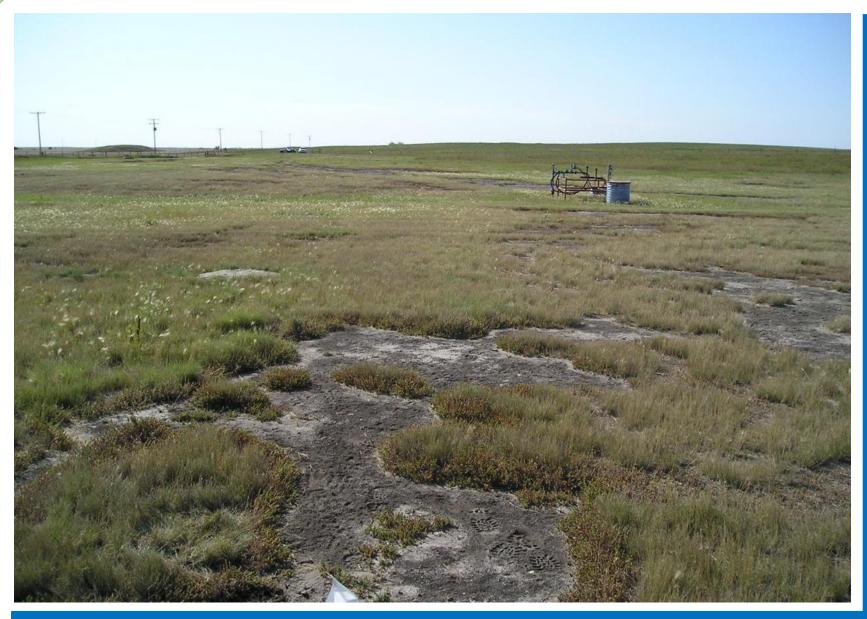
Historical Salt Spill - ECe  $\sim 10$  dS/m.

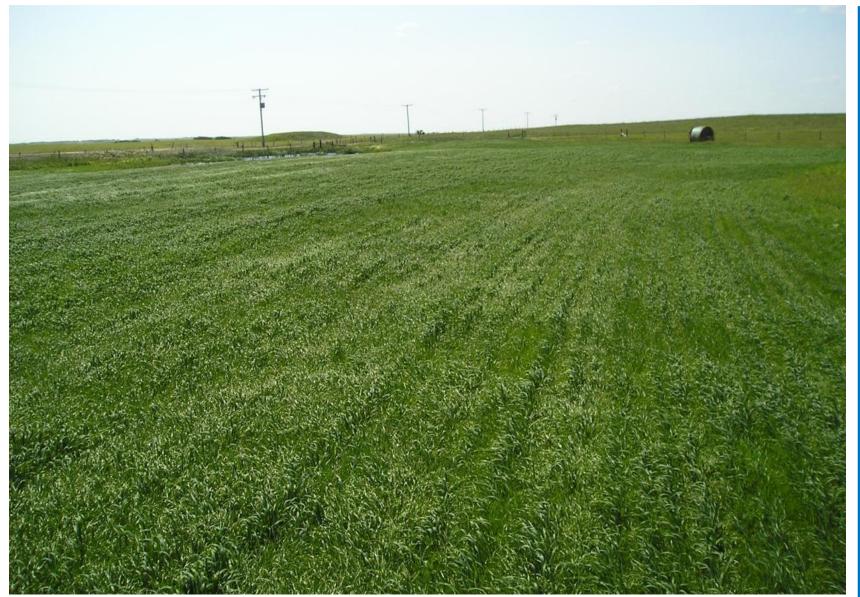
Plant growth two months after seeding.

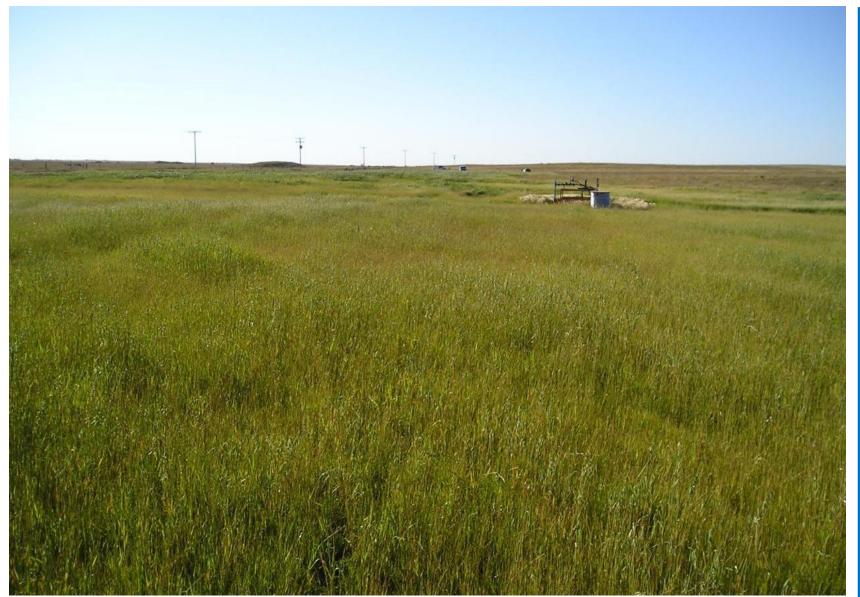
Plant growth three months after seeding.

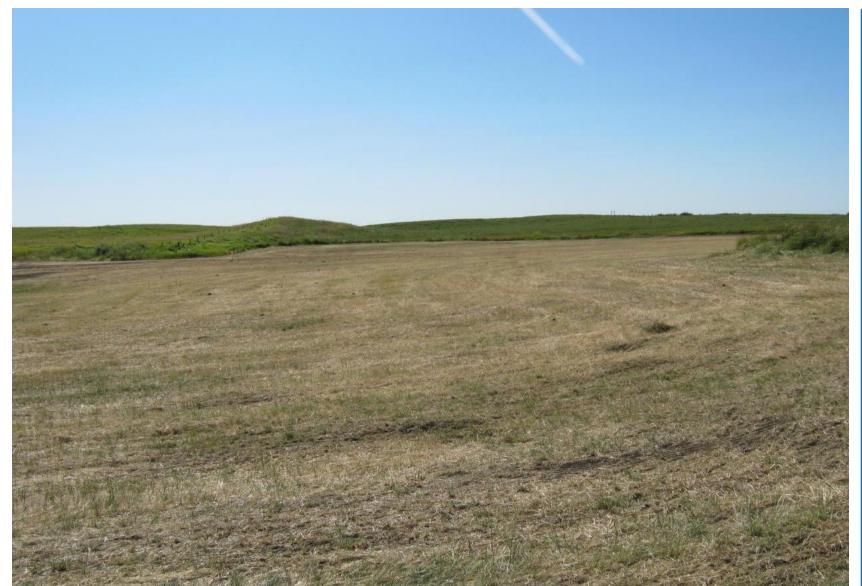
Following harvest of first year growth.

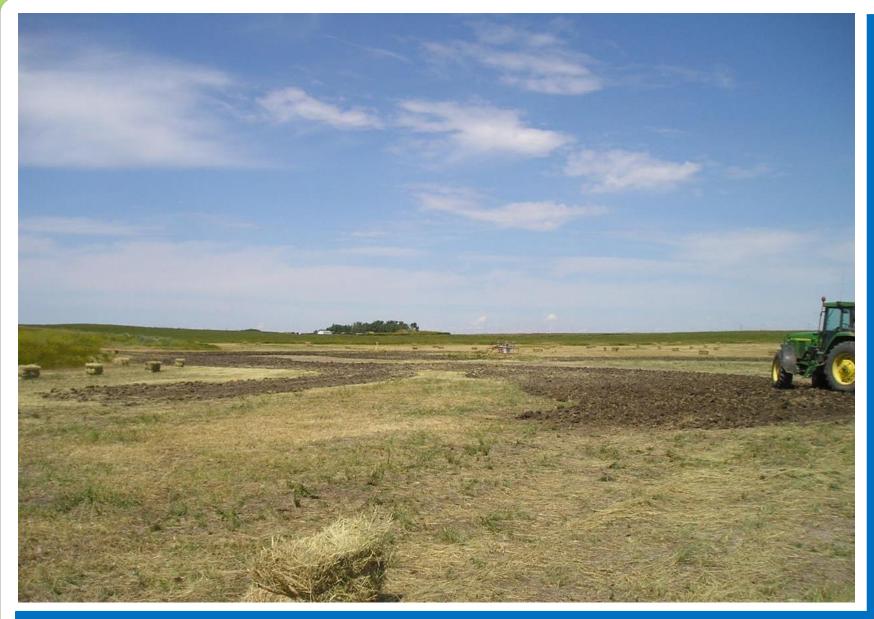
Areas of substandard growth are tilled.

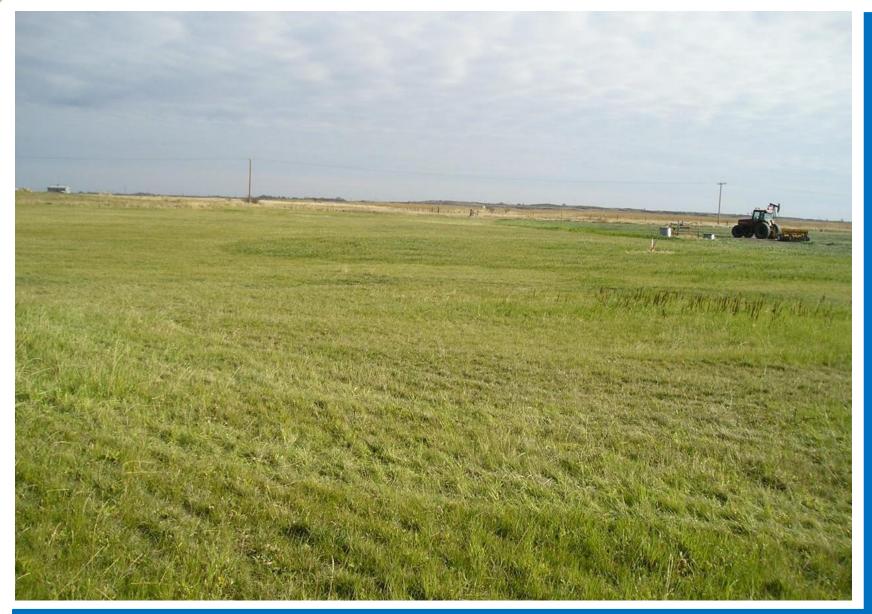
Plant growth year 2.

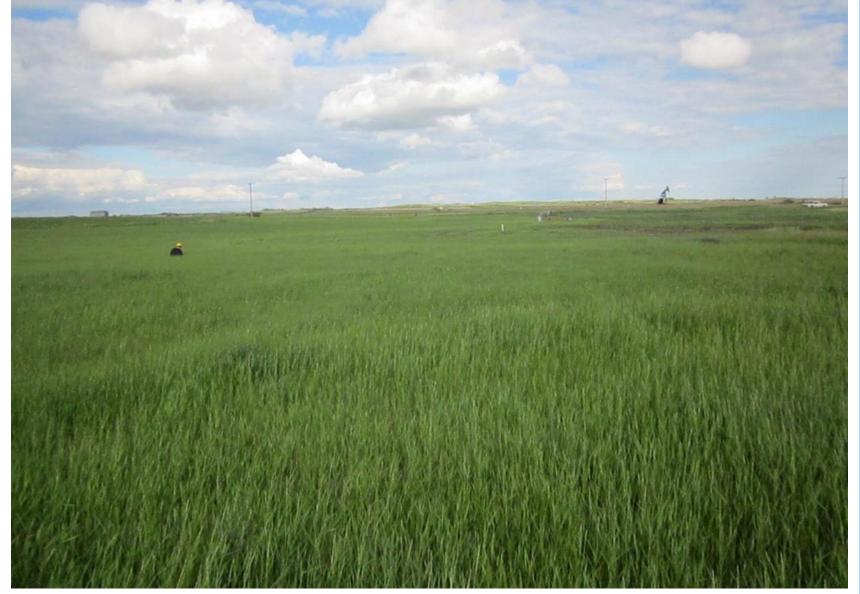
Plant growth.

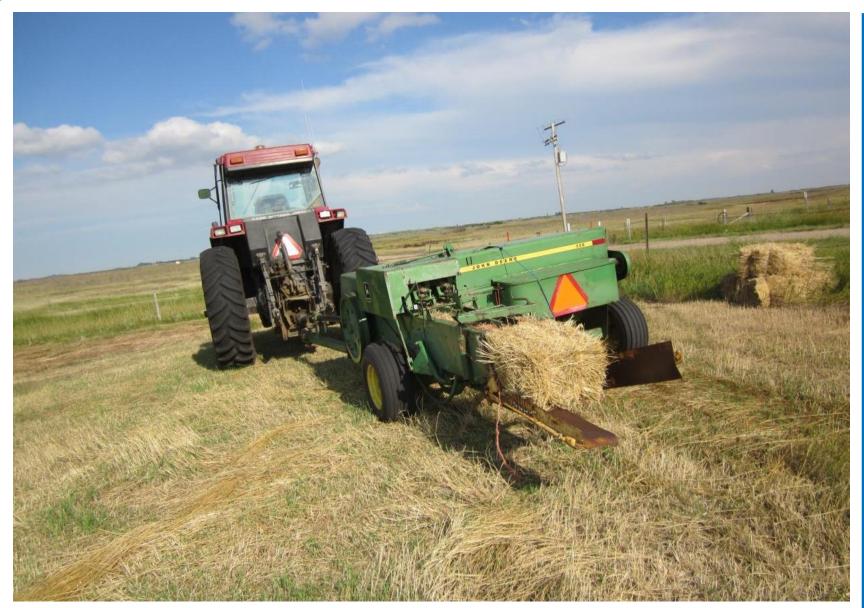
Baling vegetation for removal from site.

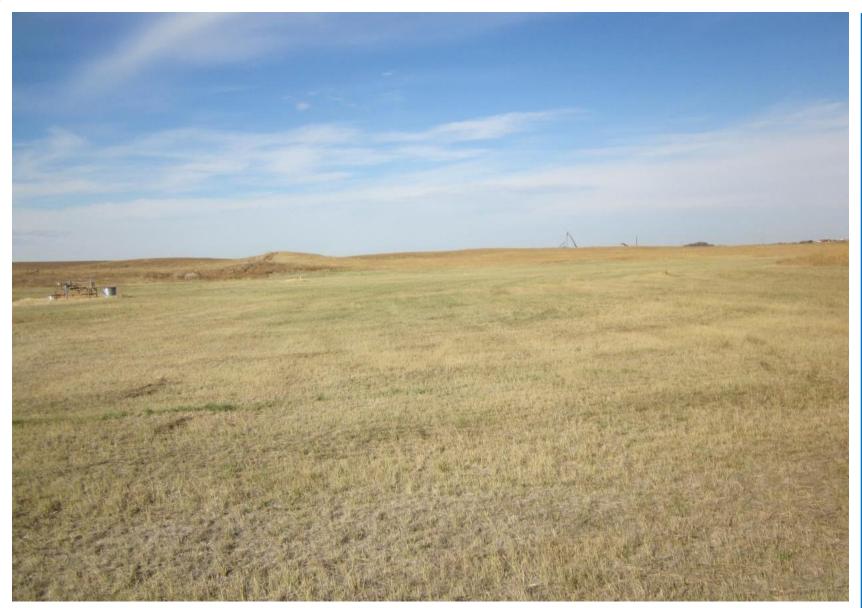
End of season plant growth.
