FISH FRIENDLY DESIGN FOR A WATERCOURSE CROSSING

Published in Canadian Reclamation Spring/Summer 2019

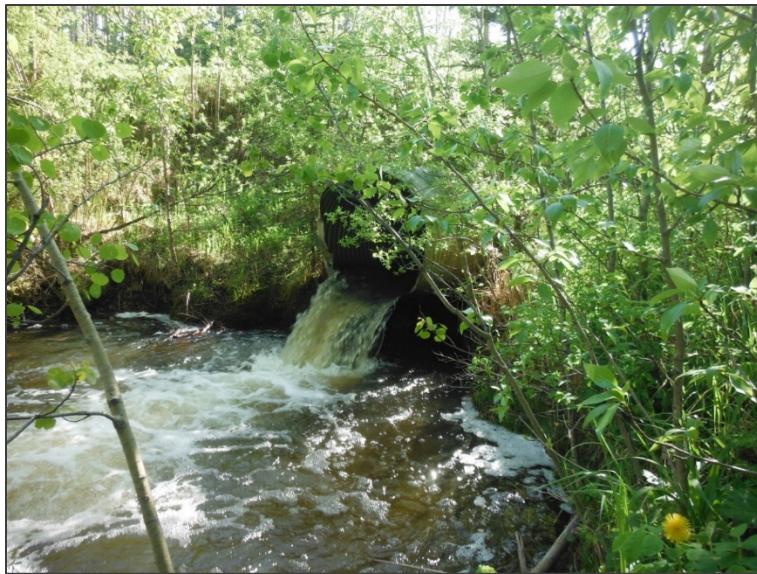
View of the outlet end of the damaged corrugated hanging culvert.

This stream crossing was non-compliant with regulatory guidelines as the inlet and outlet ends were hanging, there was active stream bank erosion, the culvert had partially collapsed, and there was no substrate in the culvert to support fish passage. The objective was to replace the existing culvert with a modular, open bottom culvert system to provide habitat characteristics closely emulated in a natural streambed, and improve stream habitat and fish movement.

An Enviro-Span polymer resin modular culvert system was chosen to replace the existing corrugated steel culvert. This system utilizes an open bottom arch design to support the road subgrade and emulate natural stream flow. Construction and reclamation activities were completed outside of the 'restricted activity' period for this fish bearing stream.

The running surface and subgrade of the overlying road were removed to expose the original culvert. Steel plate coffer dams were installed to isolate construction activities from the existing stream while the original culvert was used to maintain water flow during construction. A new streambed was constructed alongside the existing culvert and wooden poles were placed horizontally on either side to act as footings for the open bottom modular culvert. Each section of

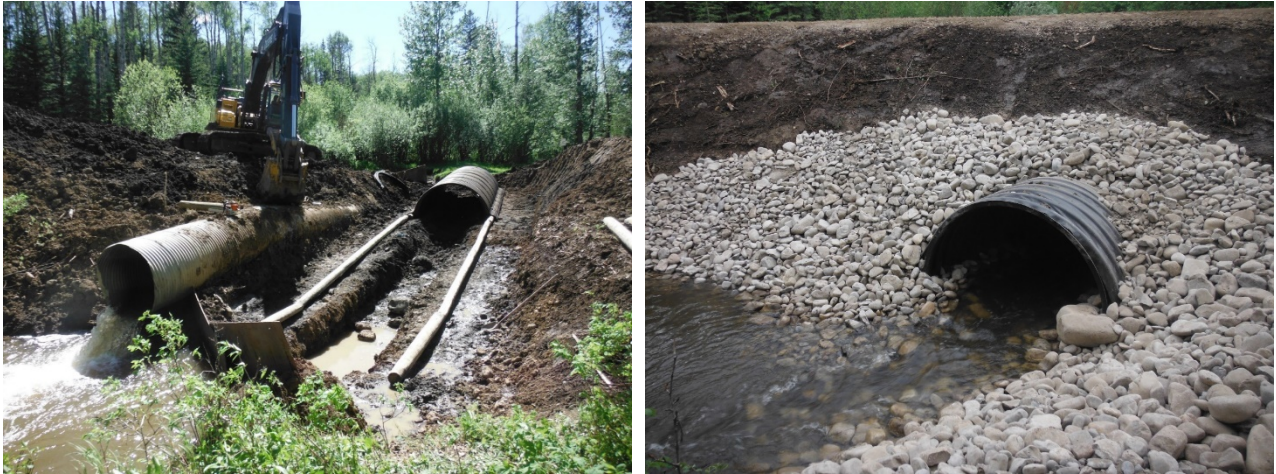
Installation of the replacement system (left), and a view of the outlet end of the newly installed modular culvert (right).

the new culvert was placed on top of the horizontal support poles and locked into place using connectors. Once the culvert was assembled and the alignment was complete, a layer of nonwoven geotextile was draped over the structure and the culvert was covered with the original roadbed material. The stream flow was introduced to the new culvert, the damaged culvert was removed, and the road surface was replaced. Following construction, adjacent ditch lines were reclaimed to allow natural water run-off from the road surface and the native vegetation was re-established. Minimal turbidity was detected during culvert replacement.
